PASSAIC RIVER BASIN
RAMAPO RIVER, PASSAIC COUNTY
NEW JERSEY

POMPTON DAM

NJ00782

PHASE 1 INSPECTION REPORT
NATIONAL DAM SAFETY PROGRAM

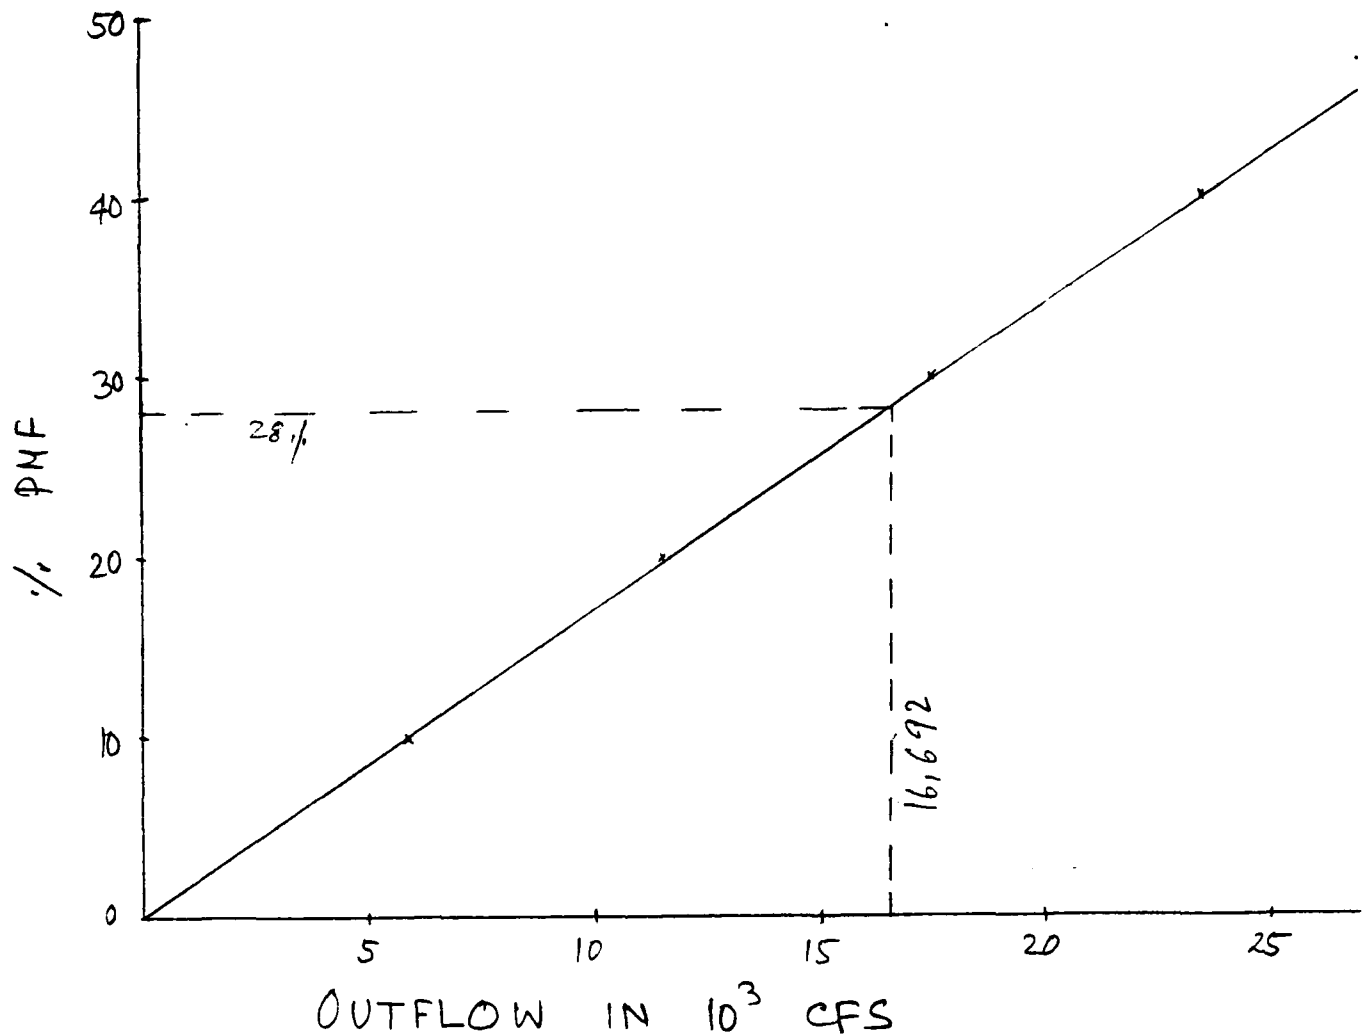
Overtopping Potential

Overtopping of Dam will occur at
28 % of PMF, EL = 182.70, $Q = 16,692$ cfs

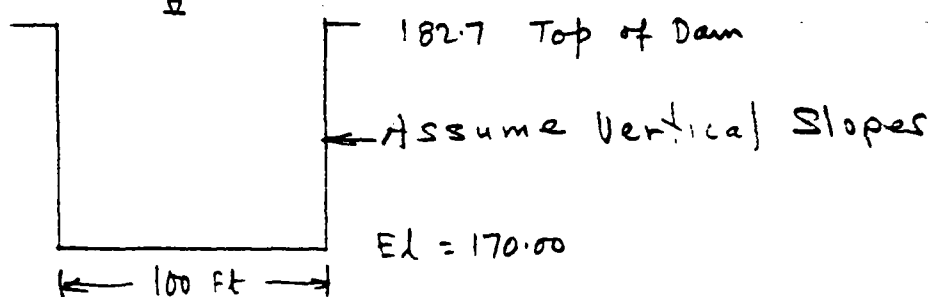
Breach Analysis

Assume breach begins to develop when reservoir stage reaches above the Dam.
Time of Failure 1 hour.

Effect of breach was analysed at 2000 ft downstream of the Dam, at 30% PMF

Maximum stage without Dam break = 176.0
Maximum stage with Dam break = 177.1
